Butyl reaching into the cavity of IGU's

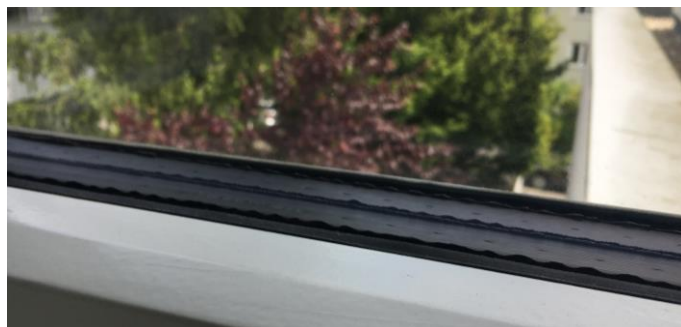
In some cases, the Butyl along the edge seal of IGU's (insulating glass units) reaches into the cavity space between the panes of glass and the spacer bar. This mostly occurs after glass units have been installed.

Image 01: Butyl reaching into the cavity

The Causes of this phenomenon can be:

- high temperatures in the fold area
- Too much contact pressure on the edge area of the glazing

Comparative tests by the Bundesverband Flachglas (BF) have shown that butyl spilling into the cavity of IGU units installed in Windows and Facades has a purely visual effect and has no consequence to the durability of the IGU unit. The study was carried out with standard triple glazed units.

It was found that a butyl overspill of up to 3mm into the cavity doesn't affect the durability and functionality of the glass and is therefore not justification reclamations. (result of the BF- Study)

Based on the results of the study, are the following recommendations are provided:

- Butyl reaching into the cavity is less noticeable if the window/frame rebate is increased within the permissible range (see DIN 18545).
- Recommended minimum butyl quantities as per the following table.

The amount mentioned here is recommended so that the durability of the IGU will not be affected.
