Butyl reaching into the cavity of IGU's

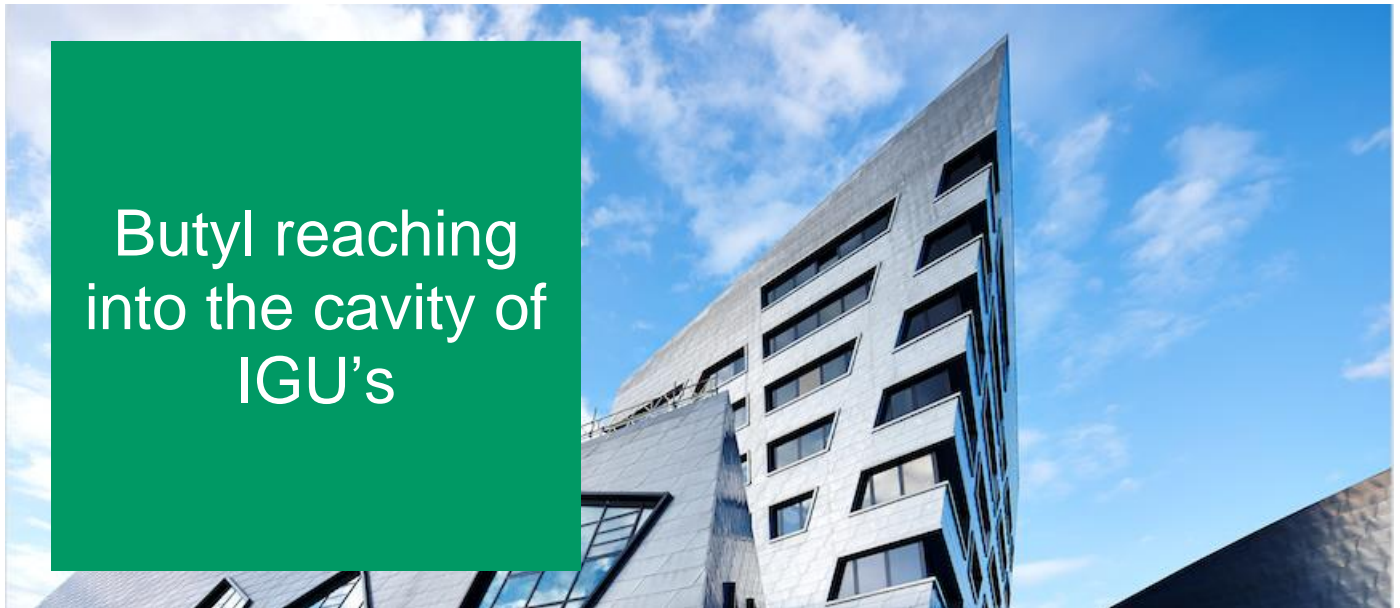
In some cases, the Butyl along the edge seal of IGU's (insulating glass units) reaches into the cavity space between the panes of glass and the spacer bar. This mostly occurs after glass units have been installed.

Image 01: Butyl reaching into the cavity

The Causes of this phenomenon can be:

- high temperatures in the fold area
- Too much contact pressure on the edge area of the glazing

Comparative tests by the Bundesverband Flachglas (BF) have shown that butyl spilling into the cavity of IGU units installed in Windows and Facades has a purely visual effect and has no consequence to the durability of the IGU unit. The study was carried out with standard triple glazed units.

It was found that a butyl overspill of up to 3mm into the cavity doesn't affect the durability and functionality of the glass and is therefore not justification reclamations. (result of the BF- Study)

- Butyl reaching into the cavity is less noticeable if the window/frame rebate is increased within the permissible range (see DIN 18545).
- Recommended minimum butyl quantities as per the following table.

The amount mentioned here is recommended so that the durability of the IGU will not be affected.
